**TEMPLE FARM,
TEMPLE ROAD,
ASLACKBY,
LINCOLNSHIRE**

Proposed conversion of existing brick barn

HERITAGE IMPACT ASSESSMENT

May 2023

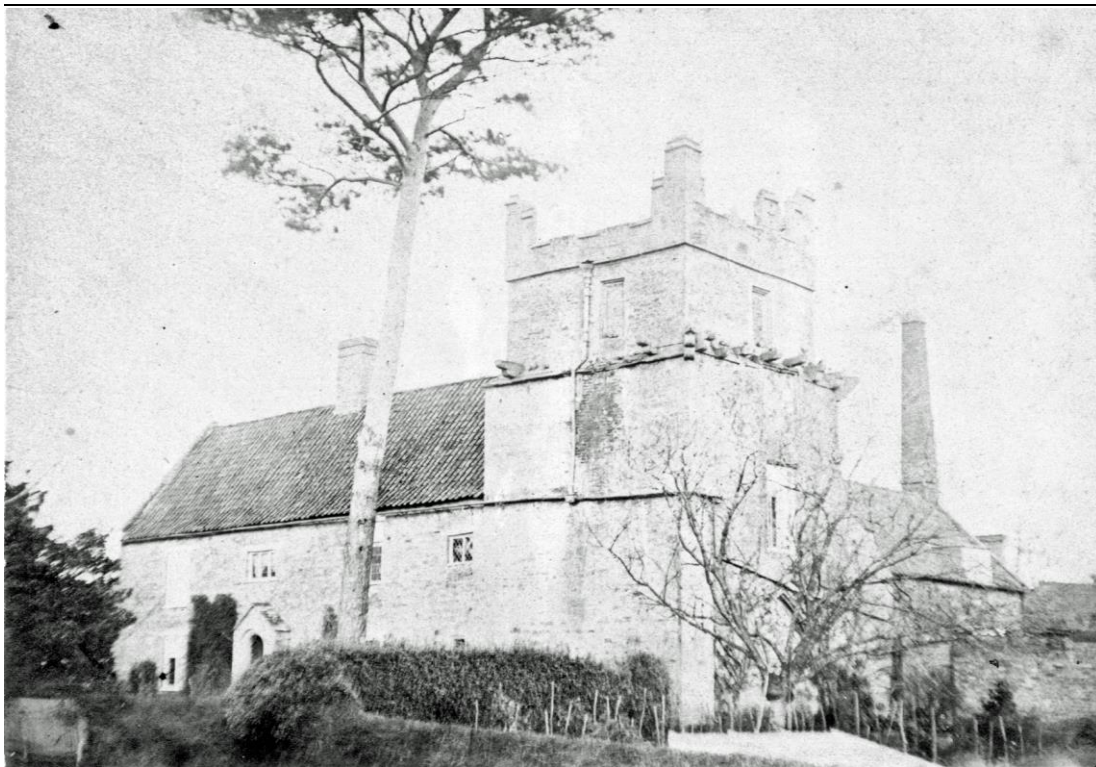
Figure 3. Photo of Temple Farm from ca 1890.

At the same time the farmhouse was rebuilt: A new storey of yellow bricks was added to form the three-storey structure that can be seen today, and the building was also shortened by about 5m toward the north. Black and white photographs from the end of the 19th century clearly show the house as being much longer some 130 years ago (Figure 3). Some 20m southeast of the present farmhouse are some 19th century brick outbuildings. They have until recently been used as barns, garages, storage sheds and sheep shelters.

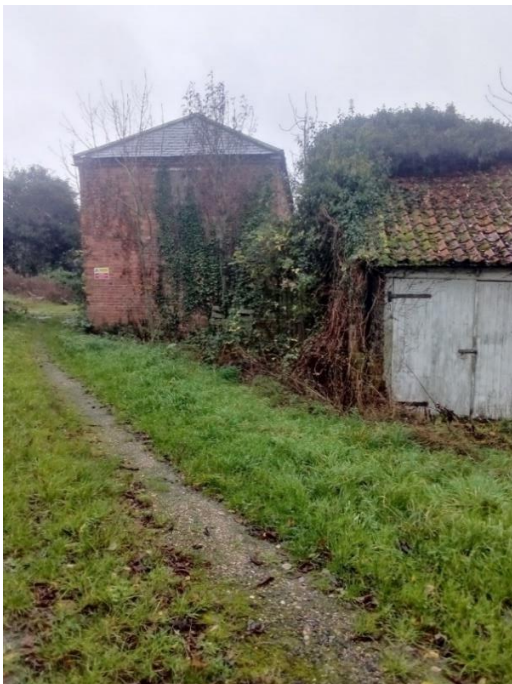
Figure 4. The 19th century outbuildings, the proposed barn conversion (Plot 4) southeast of the present farmhouse. Photo from north.

The suggested site is located in the southern parts of the farm complex, and contains existing brick outbuildings from the 19th century. It is therefore also located some distance away from the central parts of the property, and the farmhouse itself. The plot consists of a largely flat and grassy area in-between the existing outbuildings. The existing brick outbuildings are all in need of extensive restoration works. The scheme as shown in the drawings is to convert the buildings to provide one family home within the ‘footprint’ of the existing structure. The site can be reached from the existing farm driveway. The building materials and colours for proposed changes (e.g. doors and windows) will be chosen well, but the current brick structures will be left intact as far as possible in order to fit into its surrounding village setting. The changes of the view from the existing farmland in the south will therefore be negligible (Figure 4). Additional photos of the surroundings in Plots 1, 2 and 3 are attached below as Figures 5-7.

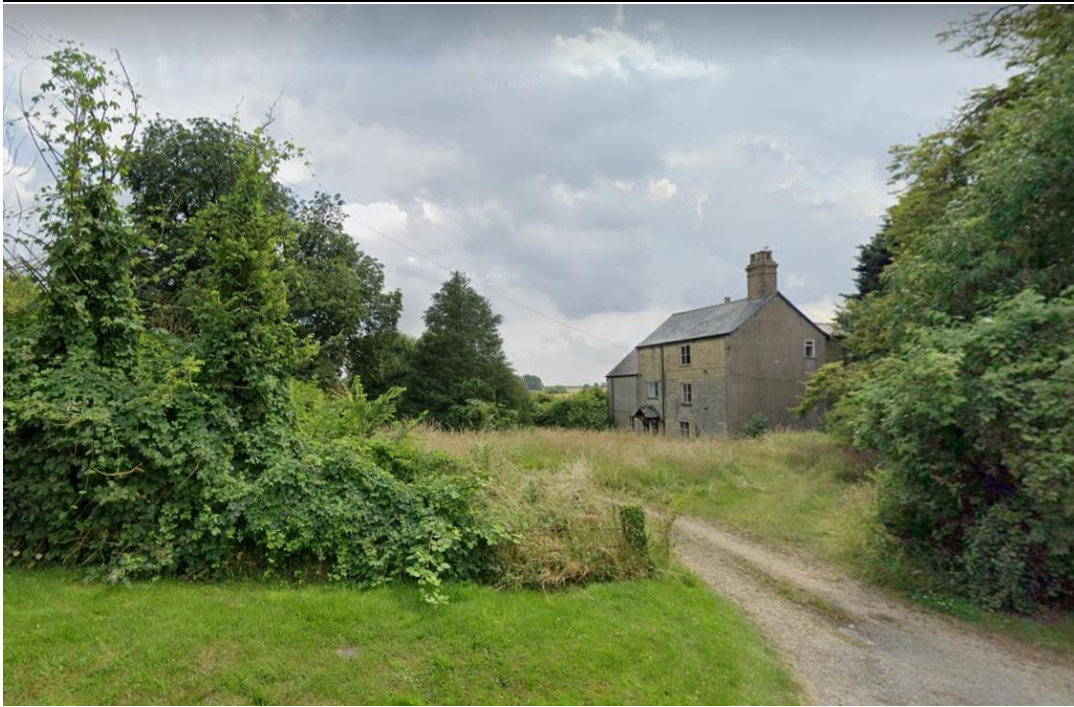
Figure 5: View of Temple Farm from Temple Road, with the suggested Plot 3 behind the bush to the left. Photo from north.

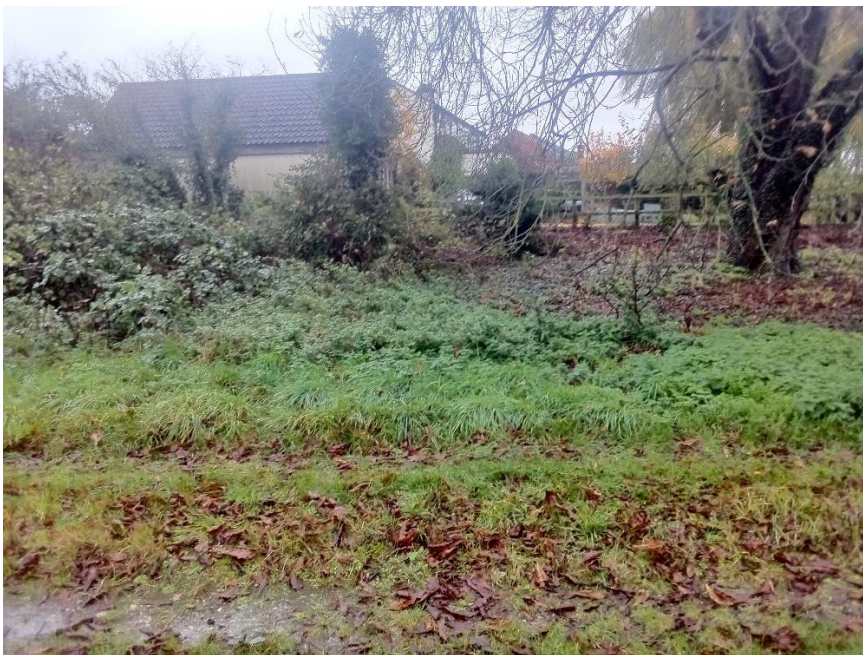
Figure 6. The Old Bakery east of Temple Farm, with parts of the suggested Plot 3 in the foreground. Photo from west.

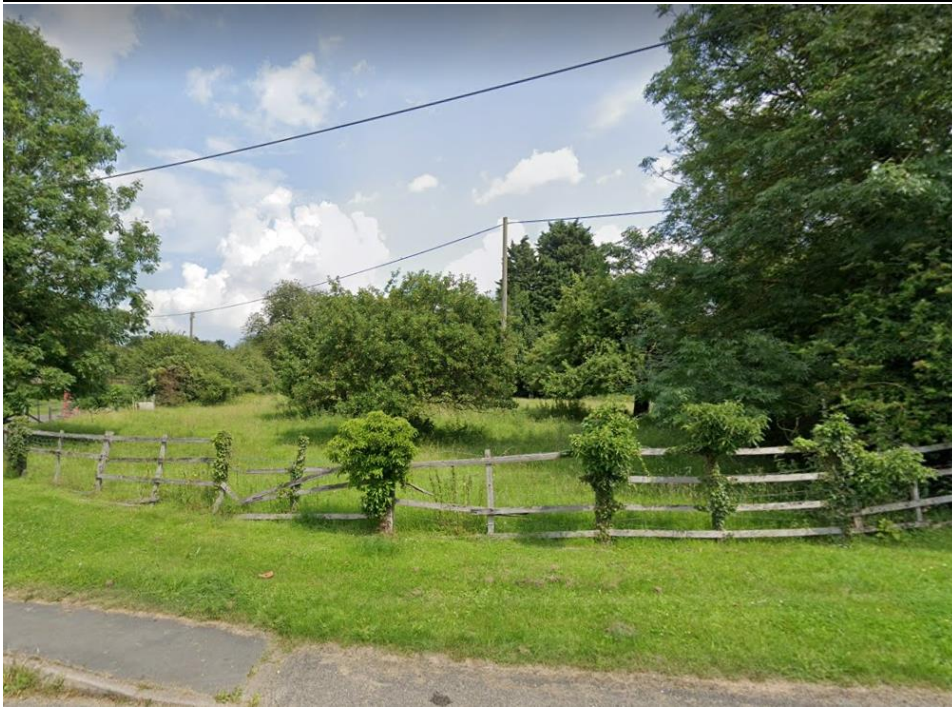
Figure 7. View of the pasture, from the road junction, with the suggested Plot 1, west of Temple Farmhouse in the distance. Photo from west.
